Approved For Release 2003/03/28 : CIA-RDP78T05161A001300010017-7 MAGERY ALYSIS TAFF PHOTOGRAPHIC INTELLIGENCE REPORT IRKUTSK AIRFRAME PLANT 25X IRKUTSK, USSR, **DECLASS REVIEW by NIMA/DOD** 25X1 CIA/PIR -75094 25X1 **MARCH** 1967 DATE COPY 110 GROUP 1
Excluded from automotic swngrading and declassification Approved For Release 2003/03/28 : CIA-RDP78T05161A001300010017-7

CIA/PIR-75094

PIR 75088

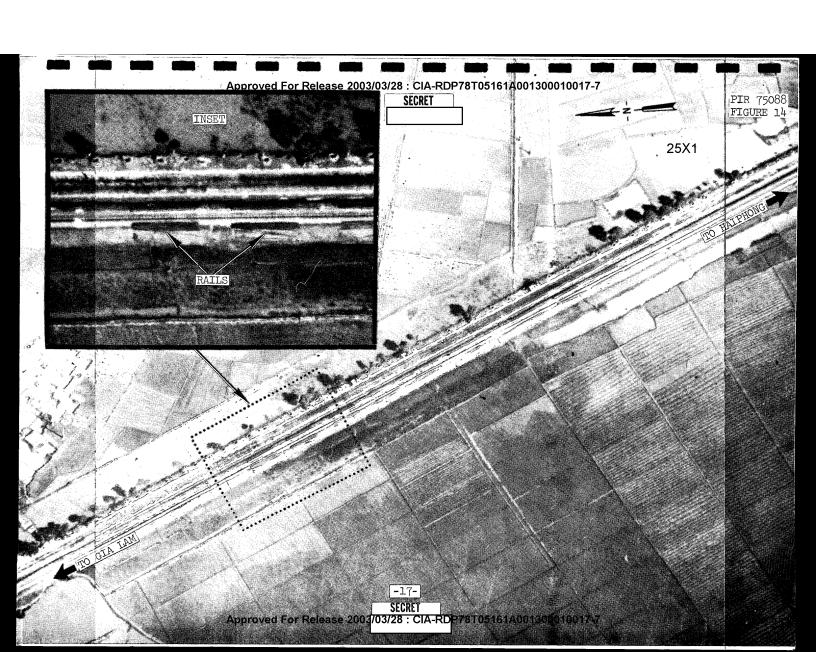
: Rails

Considerable quantities of rails (not all illustrated) were observed stacked adjacent to the railroad track in the vicinity of UTM XJ017211.
